**Re: Pre Sale Report on 45 Oliver Street, Pt Chevalier**  
**Job Ref: 8310**

## PRE SALE REPORT ON THE DWELLING LOCATED AT 45 OLIVER STREET, PT CHEVALIER

**EDEN PACIFIC REF: 8310**

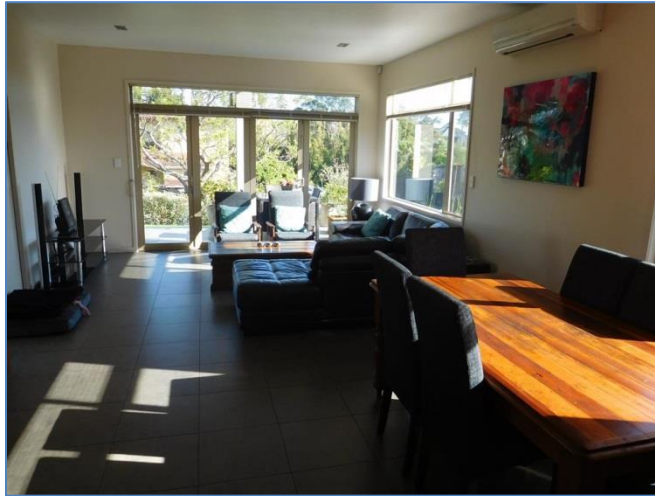
### Family and Dining Areas Combined

- 5.8 The family and dining areas are combined to provide open plan living and are located off the kitchen.
- 5.9 A set of bifold doors provide access to the courtyard.
- 5.10 The wall and ceiling linings appeared to be in good condition at the time of our inspection.
- 5.11 This area is fitted with a heat pump.

5.12 Capacitance Meter readings obtained from this area ranged from 8.3 – 12.5.

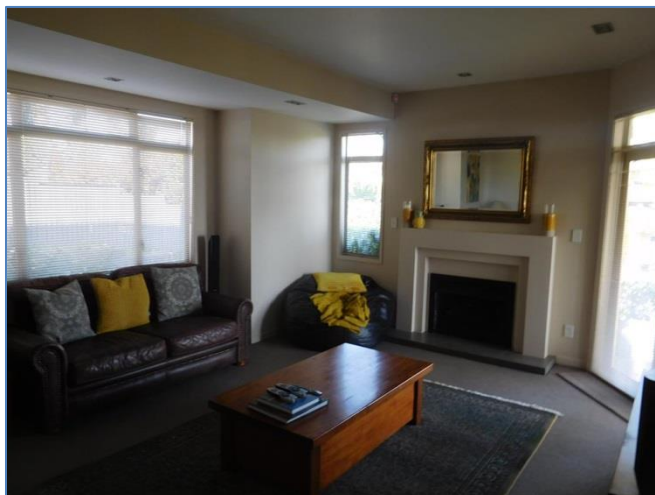
### Lounge

5.15 The wall and ceiling linings appeared to be in good condition at the time of our inspection.

5.16 The lounge is fitted with a built-in gas fireplace. We suggest this be assessed by a qualified person prior to use to ensure safe operation.

5.17 Capacitance Meter readings obtained from this room ranged from 8.0 – 12.6.

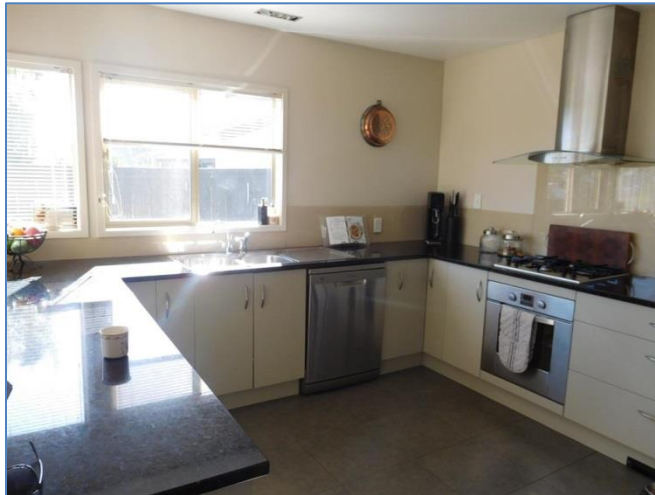
## Kitchen

- 5.18 The kitchen consists of a double stainless steel bowl, gas hob, under bench oven, dishwasher, waste disposal unit, rangehood, pantry and granite benchtops.
- 5.19 The floor covering to the kitchen is ceramic tiles which appeared to be in good condition at the time of our inspection.
- 5.20 The water pressure to all outlets is adequate.
- 5.21 The wall and ceiling linings are in good condition.
- 5.22 Capacitance Meter readings obtained from this room ranged from 8.0 – 10.6
- 5.23 Access to all exterior walls could not be gained due to built-in units.

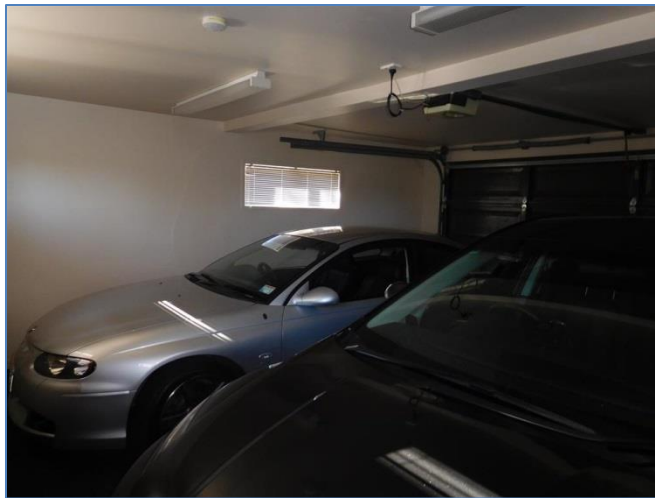
## Internal Garage

- 5.24 This is a double sized garage. There is an automatic sectional door to the garage.
- 5.25 Internal access to the house from the garage is provided.
- 5.26 Capacitance Metre readings obtained from the garage area ranged from 9.2 – 11.5.

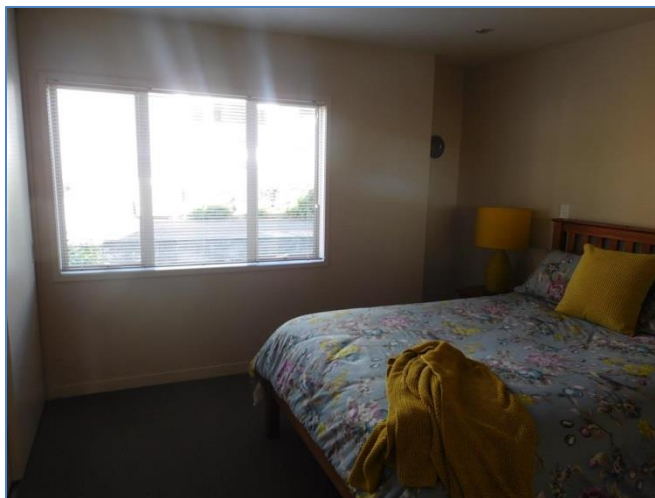
### Bedroom One (Ground Floor)

5.29 This bedroom is a double sized room with a double sized wardrobe installed.

5.30 Capacitance Meter readings obtained ranged from 10.0 – 13.0.

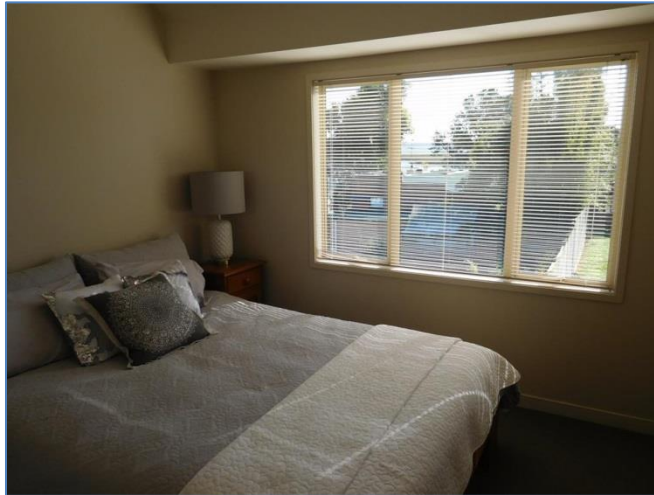
### Bedroom Two (Upper Floor)

5.31 This bedroom is a double sized room with a double sized wardrobe installed.

5.32 Capacitance Meter readings obtained ranged from 8.4 – 10.8.

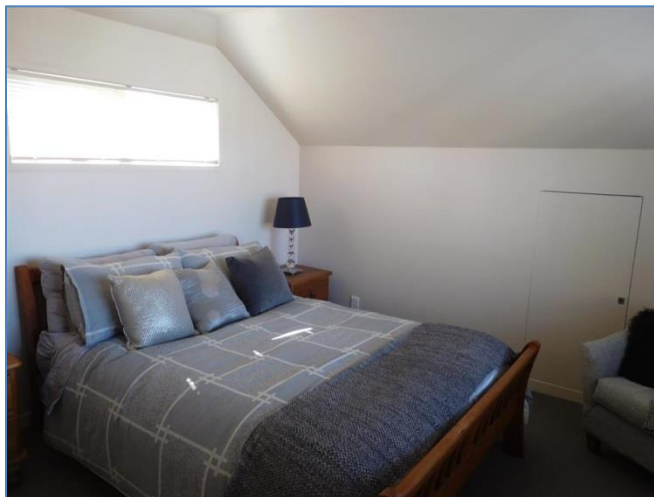
#### Bedroom Three (Upper Floor)

5.33 This bedroom is a double sized room with a single sized wardrobe installed with additional storage.

5.34 Capacitance Meter readings obtained ranged from 9.7 – 13.2.

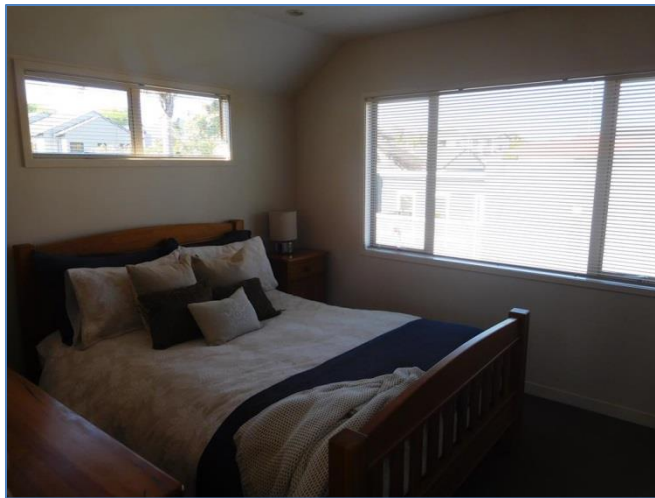
#### Bedroom Four (Upper Floor)

5.35 This bedroom is a double sized room with a double sized wardrobe installed.

5.36 Capacitance Meter readings obtained ranged from 7.5 – 9.9.

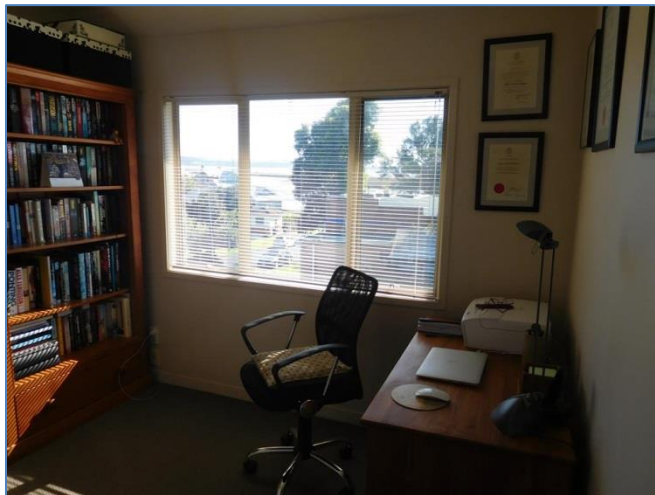
### Office (Upper Floor)

5.37 This is a single sized room with storage.

5.38 Capacitance Meter readings obtained ranged from 8.0 – 10.8.

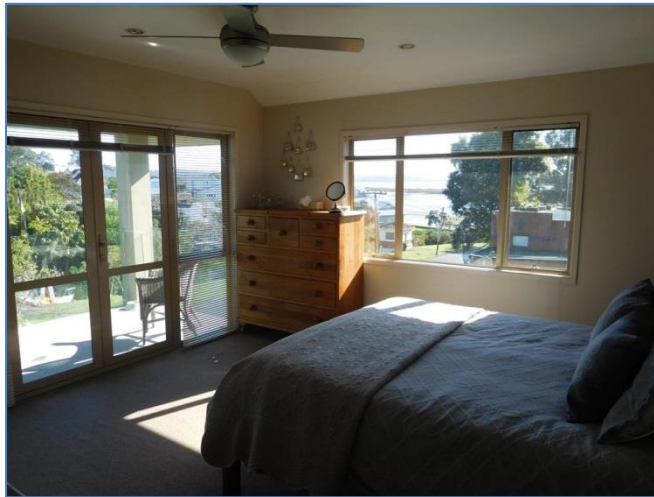
### Master Bedroom and Ensuite

5.40 The wall and ceiling linings are in good condition.

5.42 Capacitance Metre readings obtained ranged from 7.5 – 12.0.

- 5.43 The ensuite consists of shower unit, vanity, water closet, heated towel rail and wall hung mirror. The Tiled shower is reliant upon membrane beneath the tiles for waterproofing. This cannot be checked visually.
- 5.44 The floor covering to the bathroom is heated tiles which appeared to be in good condition at the time of our inspection.
- 5.45 The water pressure to all outlets is adequate.
- 5.46 Ventilation is via an opening window and mechanical ventilation.
- 5.47 Accurate moisture content readings could not be obtained due to the wall tiles.

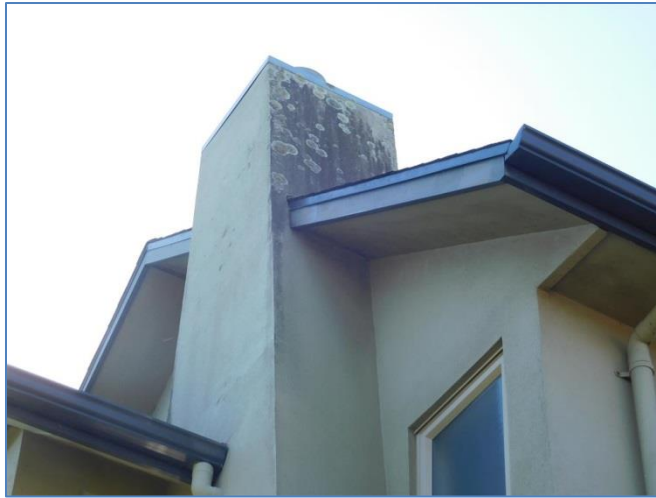
## **9.3 The paint finish is in fair condition:**

We have not been instructed, nor would it be possible without removing samples, to establish if the appropriate paint has been used. These types of cladding systems require a special paint system which is generally multiple coat elastomeric type paint. Given the importance of the paint system in providing a weathertight protective finish itself it is important to consider the requirement to undertake extensive preparation and building up the paint system in accordance with the manufacturers recommendations as part of the maintenance that will be required as alluded to above. The same applies to sealants, only good quality paintable sealants should have been used at the time of the construction/maintenance of the building. The paint is in fair condition and requires attention. It would be wise at the same time to renew all sealants that are readily accessible and exposed to the elements.

The upper gable and chimney are in need of attention.

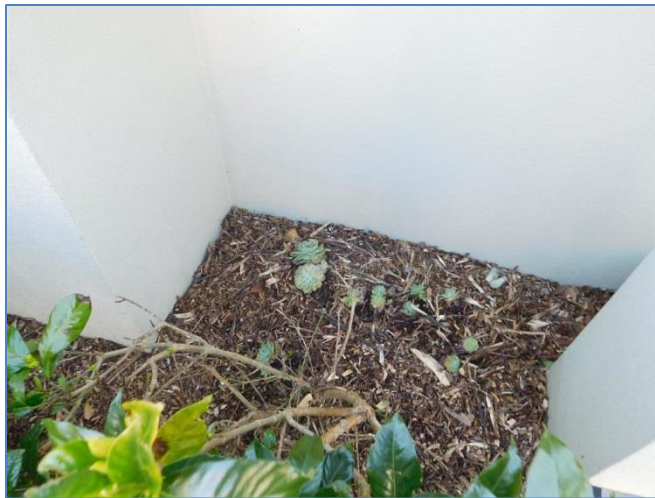
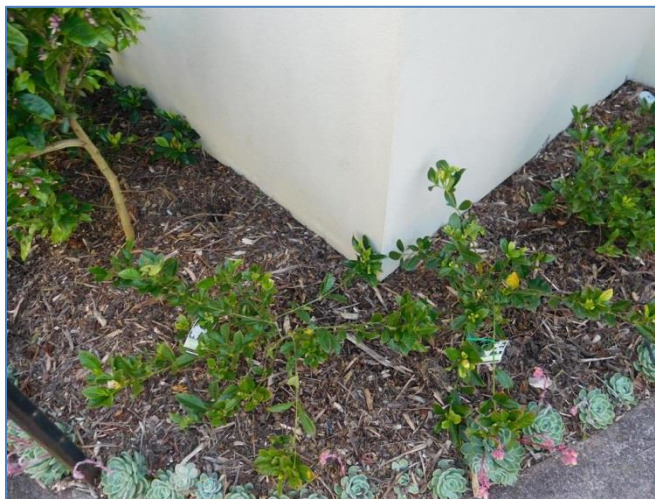
**9.4 The exterior ground level is finished at the correct height in relation to the finished floor level:**

The ground levels surrounding this dwelling meet with the above mentioned requirements.

As long as the ground levels are maintained at this height then there should be no problems in the future. Likewise we do not know if the ground levels have always been at these levels or whether the levels have been recently lowered.

Preventive maintenance is essential. And lower the mulch against the base of the cladding to provide clearance.

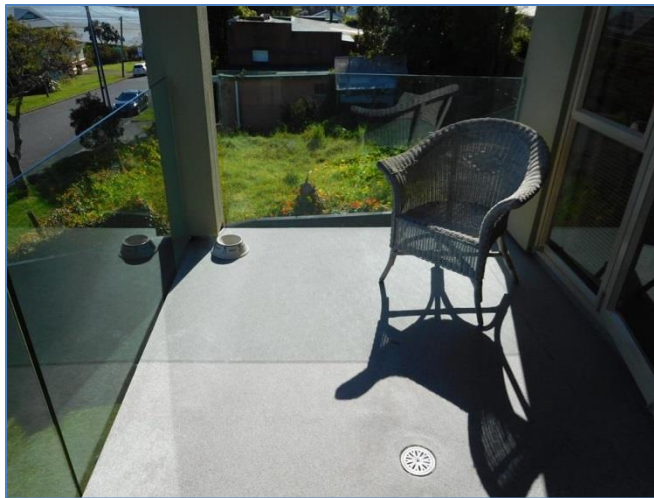
## **10. ENCLOSED BALCONIES / DECKS**

- 10.1 There is an enclosed deck with: This is located off the master bedroom and in general appeared to be in good condition at the time of our inspection.
- 10.2 Construction is of timber frame with a water proofing membrane on a plywood substrate.
- 10.3 The barrier is glass framed and appeared in good condition at the time of inspection.
